Historical materials from the medieval fortress Bač

Conservation and restoration of cultural heritage are the objects of great interest worldwide. For setting the correct methodology for the procedures of the restoration it is very important to have the right information about the state of the object and the characteristics of the original materials. The basis of our examinations were clay products (samples of bricks, terracotta and clay roof tile) from the middle ages, the fortress in Bač. The following methods were used: x-ray diffraction, classic chemical analysis, SEM-EDS, Hg-porosimetry and dilatometry. Based on the used methods, mineral composition, temperature and regime of firing and textural properties of the examined materials were determined. The degree of destruction of examined materials was also identified, in order to find compatible materials for future techniques of conservation and restoration.

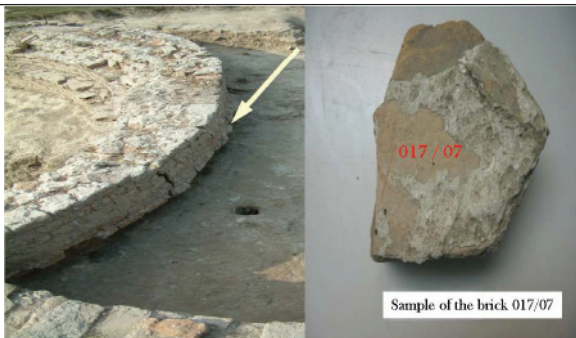
<i>Sample</i>	<i>Features</i>	<i>Position</i>	<i>Picture</i>
The sample of brick 017/07	Orange coloured sample covered with the layer of lima mortar	Base of the brick wall (excavated wall of the medieval palace)

Brick 017/07 is a ceramic product based on quartz, feldspar, calcite and diopside. It was fired in reducing atmosphere, at low temperature (570°C). The interval of dominant pore radius is between 0.5 and 1 μm, with a 18 vol.%. The product as a hand-modeled element, possesses a low water absorption value (18.74 mass%).

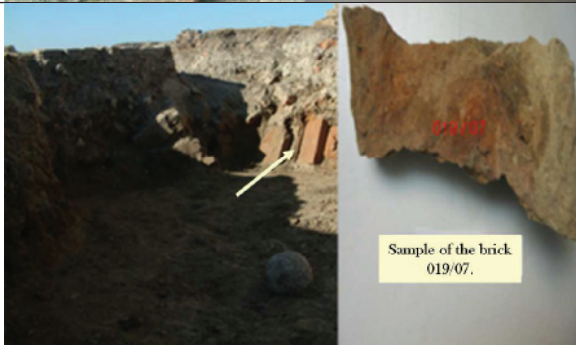
The sample of brick 019/07	Light-red-orange coloured sample	Base of the brick wall (south-east wall)

Brick 019/07 consists of newly formed crystal phase: mellilite (Ca, Na/K) (Mg,Al, Fe) (Si₂O₇) beside mineral components as quartz, feldspar and mica originating from the raw material mixture. It is a system fired at 780°C mostly in oxidative atmosphere. The interval of dominant pore radius is the same as in the case of the brick sample 017/07.

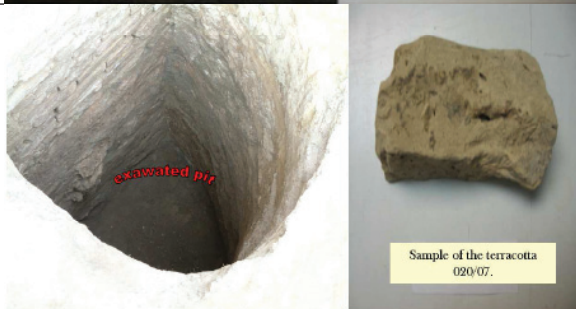
The sample of terracotta 020/07	With-creamy coloured sample covered with light orange-brown coloured layer	Excavated pit (Buried pit under the fosters)

Terracotta 020/07 is a creamy-white ceramic material (mass.% Fe₂O₃ in traces and high mass% of CaO–15.47 % originating from calcite and diopside), consists of new crystal phases as mellilite and diopside. Those such as, quartz, feldspar and calcite are originating from the initial raw material. High temperature of firing (900°C) with the use of organic materials (probably straw) is a characteristic of this system. EDS analysis of the surface of the sample 020/07 (coloured layer 021/07) shows the presence of manganese, which, together with the literature data, confirms the presence of a red pigment – Red fired Siena.

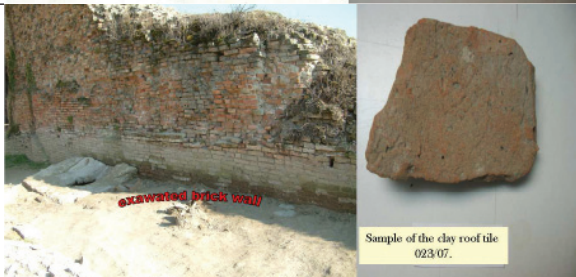
The sample of clay roof tile 023/07	Red-orange coloured sample	Excavated brick wall (in-layer of the south-east brick wall)

Clay Roof tile 023/07 is an orange-red ceramic material (4.80 mass% Fe₂O₃), which consists of quartz, feldspar (primary anorthite form), calcite and mica as the original materials and newly formed phase as hematite. Firing temperature of 670°C was determined based on dilatometric analysis.
